MRI Laboratory Safety Manual

UCLA
Brain Mapping Center

**Ahmanson-Lovelace Brain Mapping Center
University of California, Los Angeles**

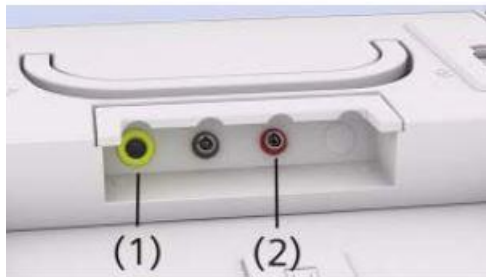
Prisma squeeze bulb connector at the foot of the bed is labeled (2) and the hose connector is red

The scanners are equipped with a squeeze bulb that allows the participant to set off an audible alarm to attract the operator’s attention. The squeeze bulb should be made available to participants unless some alternative method of constant monitoring (e.g., another person in the scanner room) is in effect. Use of the squeeze bulb or some comparable form of continuous participant monitoring is mandatory if you are operating the scanner in “Level 1” mode, which has an increased risk of magnetostimulation or participant heating due to RF energy deposition or if you are scanning a participant who has a tattoo or permanent eyeliner. The squeeze bulb plugs into the red connector at the foot of the bed. If the participant squeezes the squeeze bulb, a continuous audible alarm is emitted via the intercom and the intercom alarm button lights up.

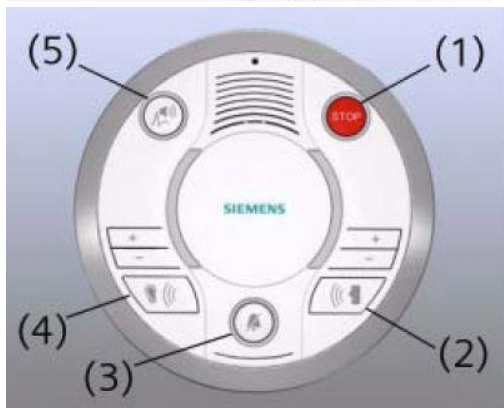
- The “STOP” button is labeled (1)
- The talk button is labeled (2)
- The reset patient alert button is labeled (3)

3. For the Siemens system, press the patient alert button (#3)
4. While holding down on the appropriate intercom talk button, speak to the participant to determine why the squeeze bulb was pressed. **Make sure that the volume is turned up so that you can hear the participant's response.**
5. If necessary, enter the room to further investigate and/or correct the problem.

- A. If the emergency involves a participant in the magnet and there is power to the scanner:
 - a. Use the mouse to click on the stop icon on console screen, or alternatively, press the "STOP" button (#1) on the Siemens intercom to abort the scan.
 - b. Remove the participant from the scanner by pressing the home button on the gantry.
- B. If the emergency involves a participant in the magnet and the power is out or the table is stuck:

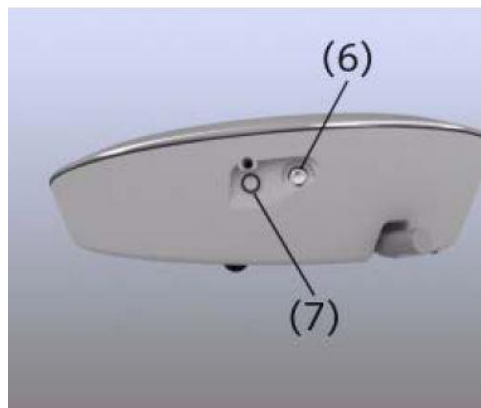
The reset table stop button is labeled (7)

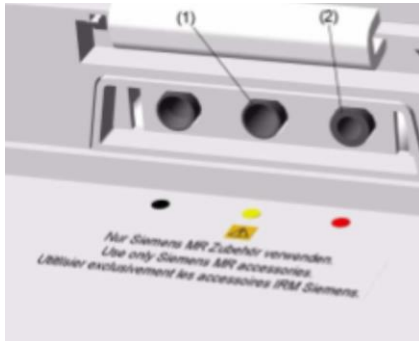
mMR squeeze bulb connector at the foot of the bed is labeled “(2)” and the hose connector is red.

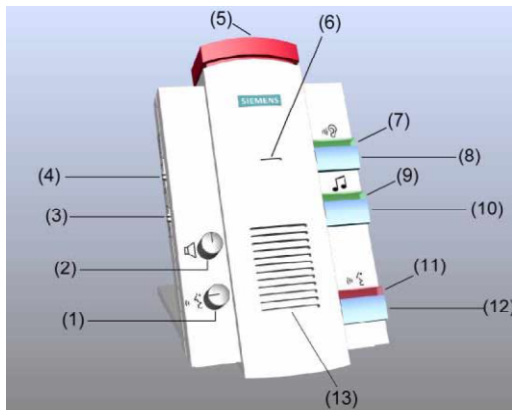
The squeeze bulb LED is labeled “(11)”, the talk button is labeled “(12)”. The “STOP” button is labeled “(5)”.

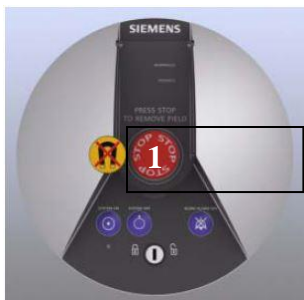
Prisma and mMR control room quench button is labeled (1) in the picture

1. Locate and press the QUENCH BUTTON in the control room or scanner room. The magnetic field will fall to a safe level within 20 seconds.
2. In the control room, the quench button is located on the top portion of the Siemens wall mounted control boxes located just to the right of the window. The Prisma control room quench button is covered by a tamper evident plastic cover. The quench button itself has the word "STOP" printed three times around its perimeter. Lift the plexiglass cover and press the button.

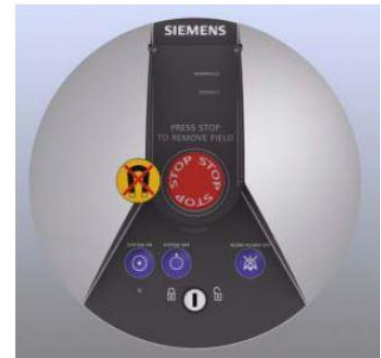
5. Notify ALBMC staff that you have performed a Routine Electrical shutdown. [Contact information](#) is located on the last page of this manual.
6. *If it is appropriate to restore power (wait at least 5min), press the blue “power on” button located on the Siemens control box next to the control room window. The system will need approximately 5 minutes to reinitialize. To avoid subsequent problems, make sure that the bed is completely out of the gantry at its home position (all the way out and all the way up) and that the top head coil is attached and plugged in or off the table before restoring power.*

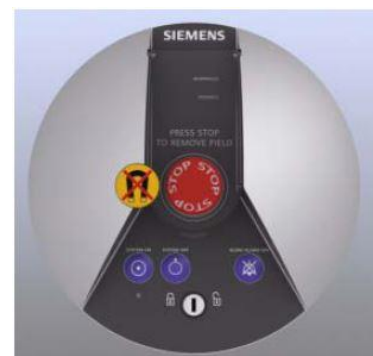
6. Press the blue “system off” button on the Siemens scanner control box located on the wall next to the MR Scanner window

8. *If it is appropriate to restore power (wait at least 5min), press the blue “power on” button located on the Siemens control box next to the control room window. The system will need approximately 15 minutes to reinitialize. To avoid subsequent problems, make sure that the bed is completely out of the gantry at its home position and that the top head coil is attached and plugged in or off the table before restoring power.*

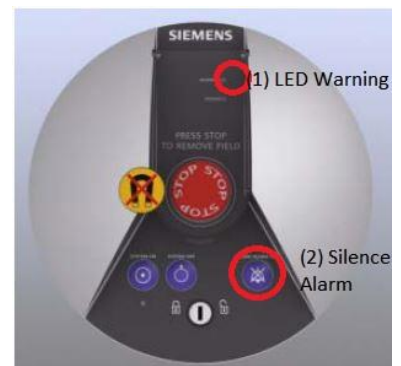
3. The helium level might be low or the magnet might have quenched spontaneously due to an earthquake or as a result of someone pressing the quench button. Check the Siemens control box located in the control room immediately to the right of the window. If the warning LED is lit, there could be a potential issue such as low helium, power problems, compressor problems, battery problems and/or communications errors. You can press the alarm silencer to

stop the audible alarm, but **do not scan**. Notify ALBMC staff of the problem and send your participant home.
